DOT/FAA/CT-85/25

Seat Experiment Results Full-Scale Transport Aircraft Controlled Impact Demonstration

Mark R. Cannon
Richard E. Zimmermann

July 1986

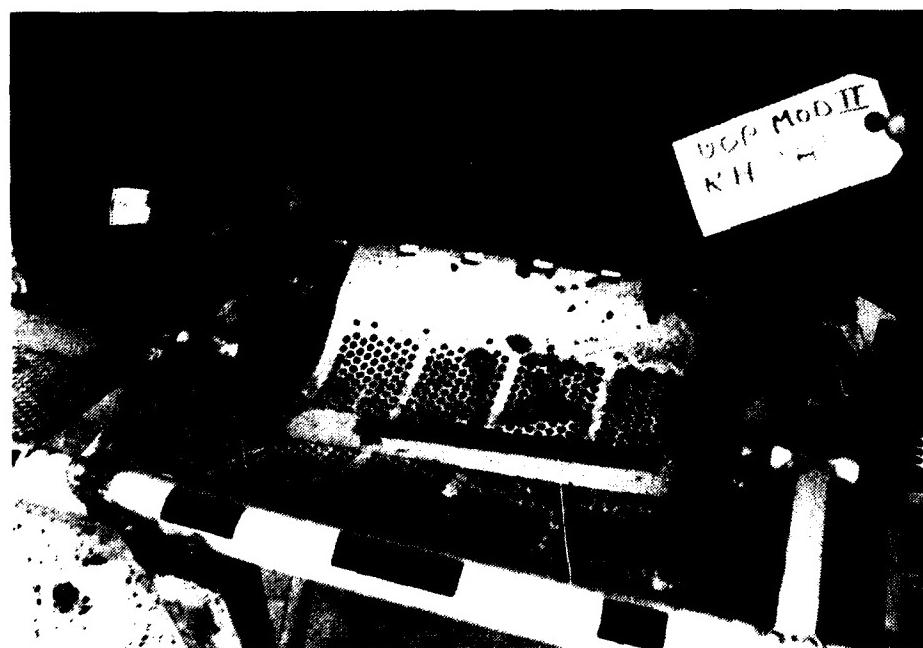
A common occurrence found on three seats was the deformation of the right side of the center seat pan. Figure 53 shows the locations of these seats and figures 54-56 show the seat pans. Onboard films showed the dummies in these seats leaning to the right and bouncing during the obstacle impact and slideout. The accelerometers from seats H/R and B/L indicated peak vertical accelerations of 40 G with 10-msec durations.

Figure 55. Seat pan deformation of seat H/R.

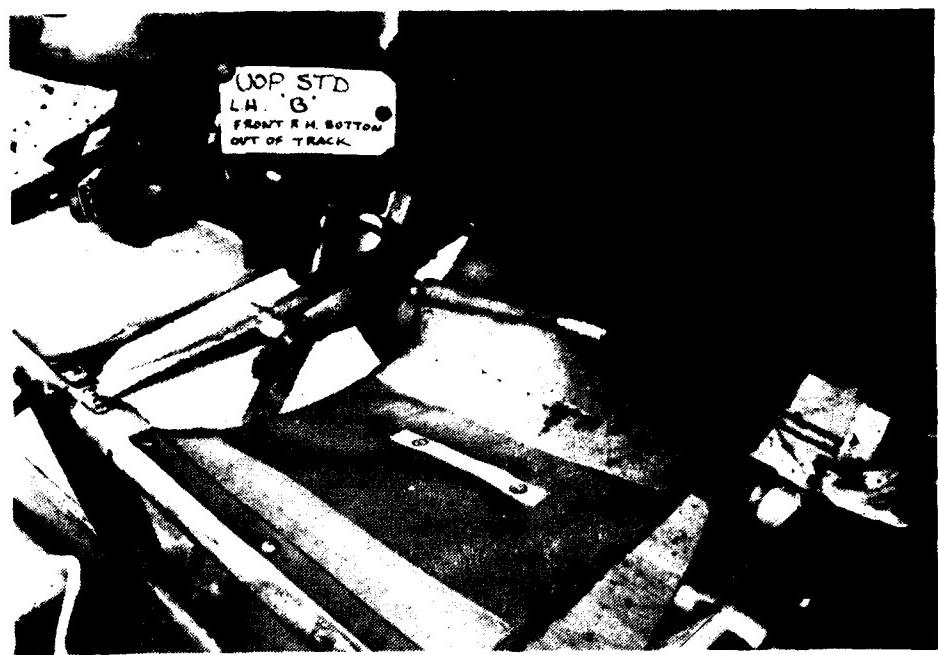
Figure 56. Seat pan deformation of seat B/L.

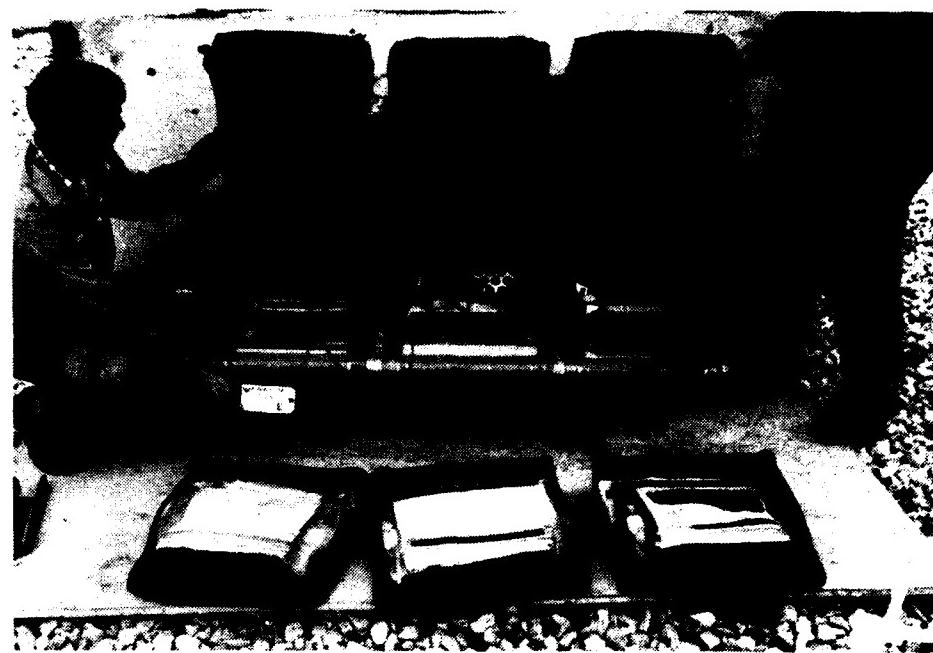
SEAT E/L. This seat was across the aisle from seat A/R and was found in a similar orientation, due to the floor collapsing. It also sustained similar fire damage; one of the plasticized seat pans had melted and the upholstery was blackened (figure 58).

Figure 58. Damage to seat E/L.

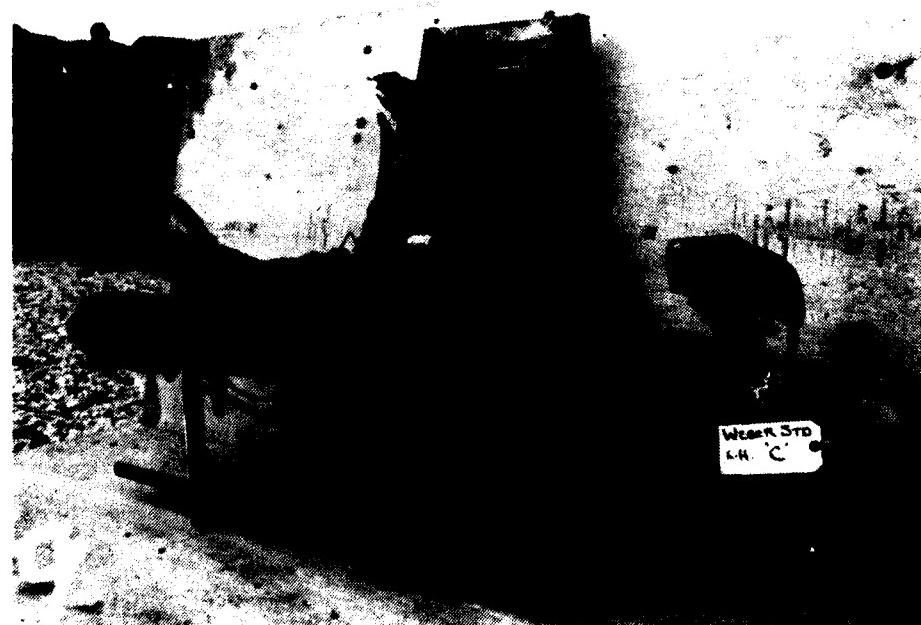
SEAT C/L. No damage from the impact was sustained by the seat. However, the fire destroyed both outboard and inboard seat backs and part of the center one (figure 59).

Figure 59. Damage to seat C/L.

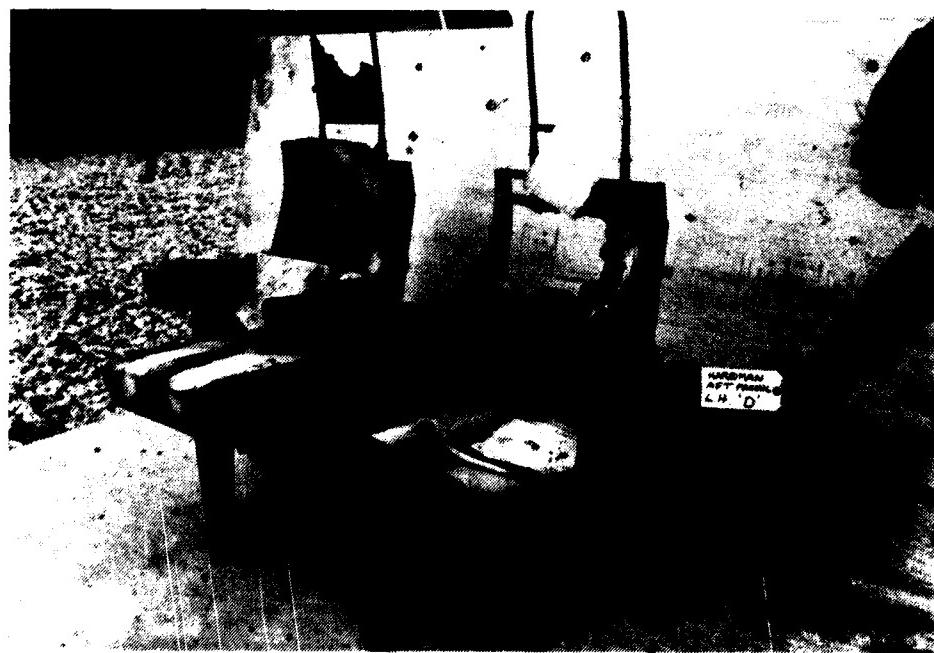
Figure 63. Damage to seat D/L.

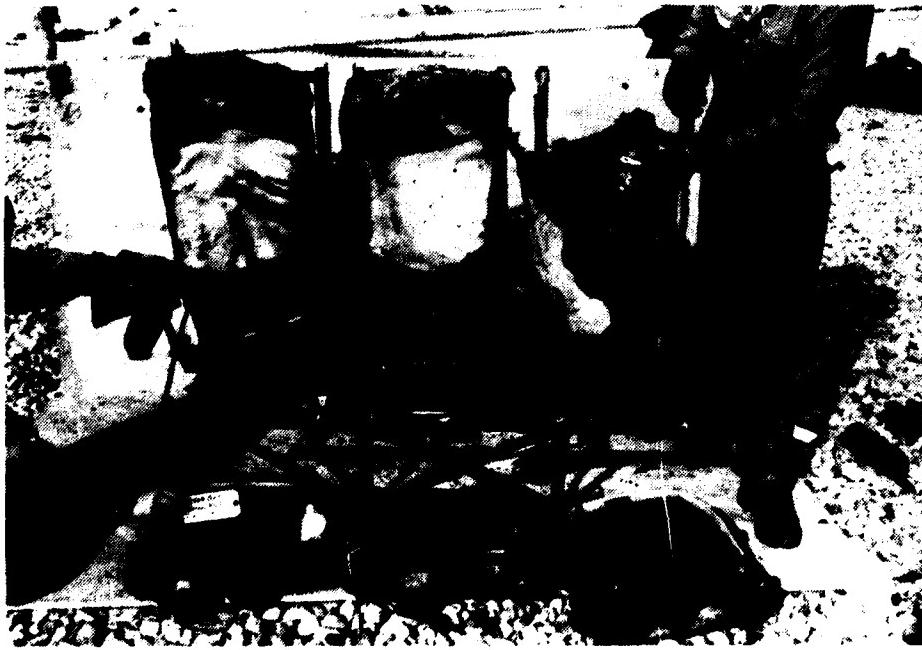
SEAT K/L. The fire melted the seat pans and partially melted the seat backs and leg structure. There was no damage from the impact (figure 65).

Figure 65. Damage to seat K/L.

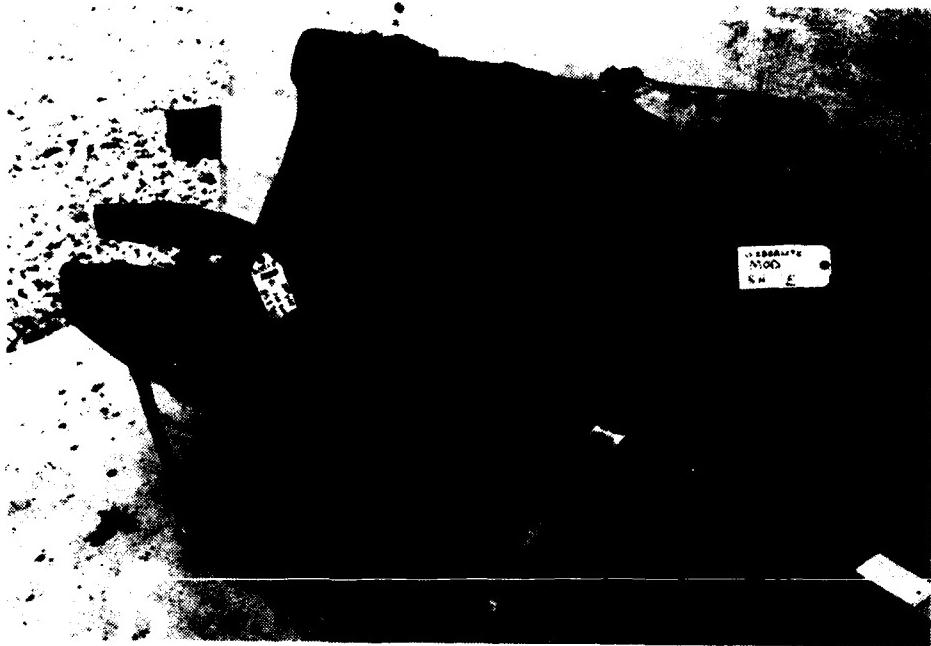
Figure 68. Damage to seat E/R.

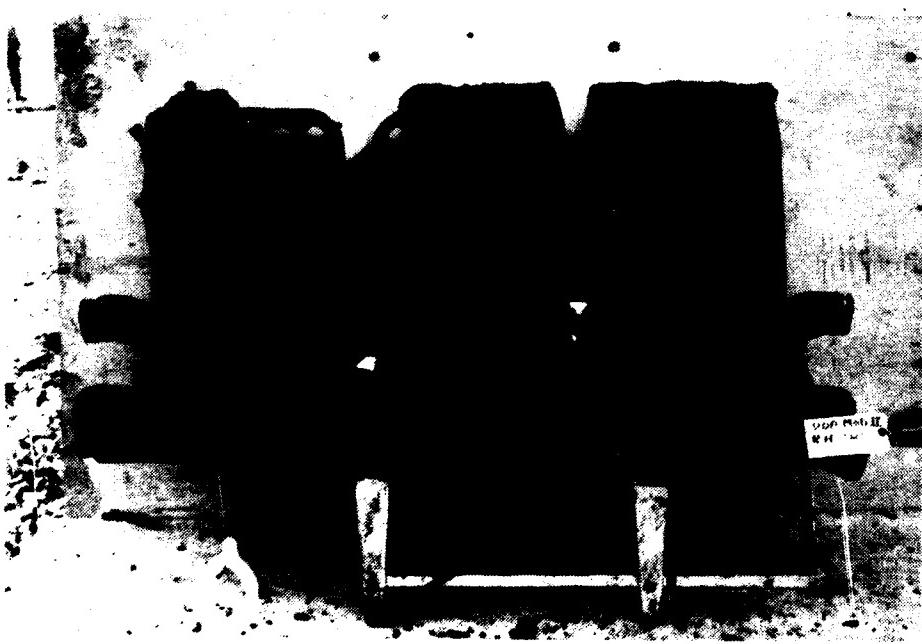
Figure 69. Damage to seat H/R.

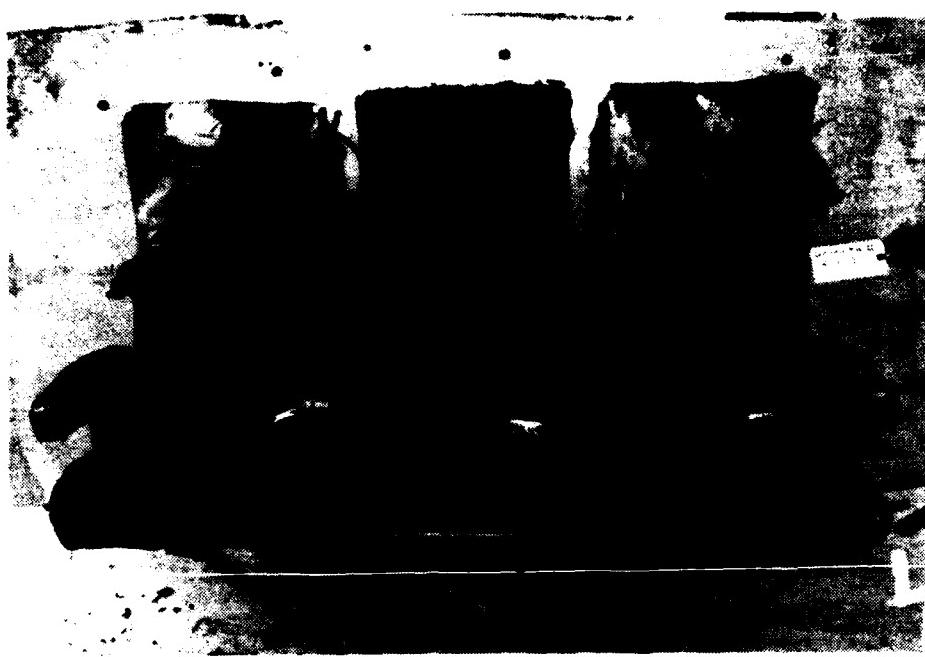
Figure 70. Damage to seat I/R.

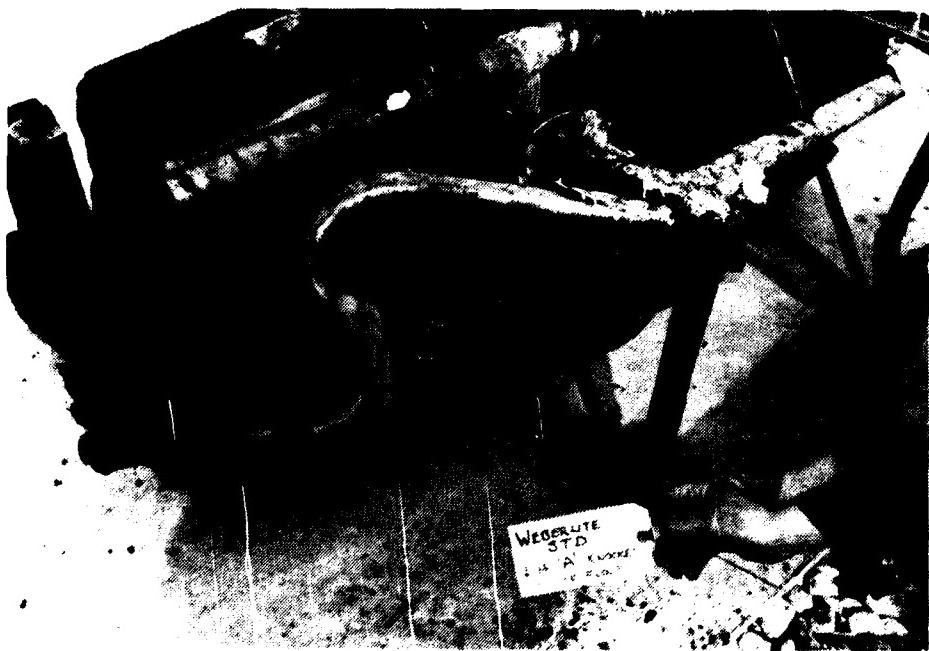
Figure 73. Damage to seat A/L baggage restraint.

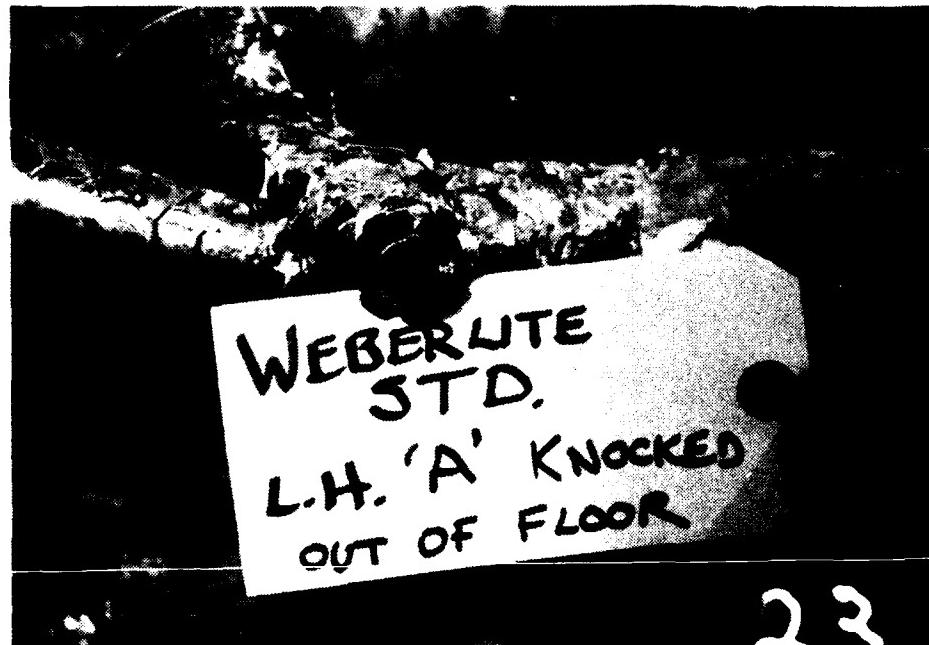
Figure 74. Seat A/L front inboard track button.

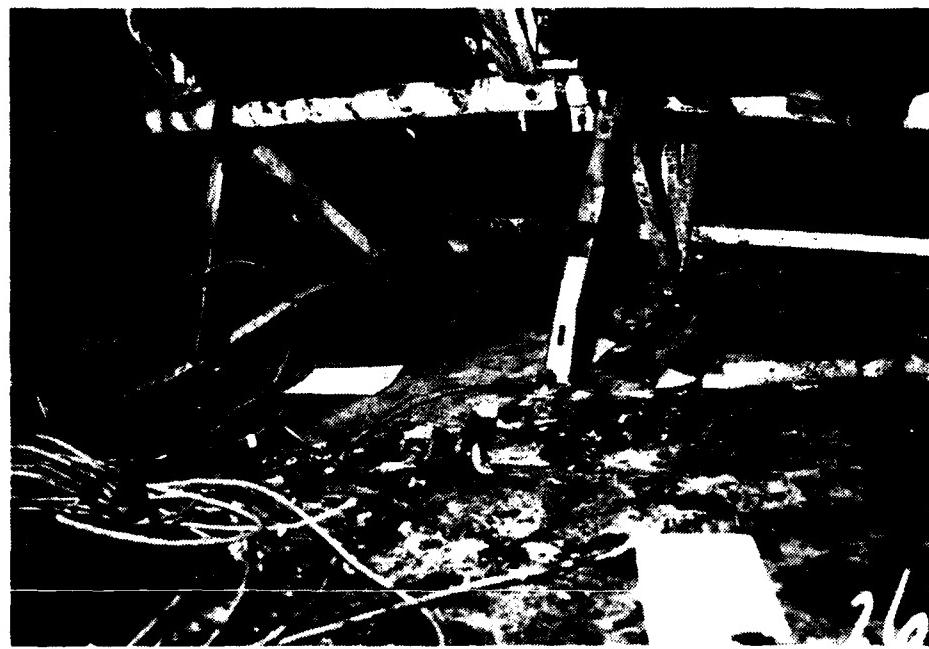
SEAT B/L. During the obstacle impact, a landing gear hub struck the underside of the floor structure directly beneath the outboard track cover bar that connects the front and rear seat legs. The floor broke and assumed the shape of an inverted V. Since the track cover bar was lying flush over the floor track, it also assumed the same shape (figure 75). The deformation of the floor also caused the outboard front track fitting to come loose from the floor track (figure 76), leaving the seat supported by three legs.

Figure 76. Deformation of floor due to gear hub impact.

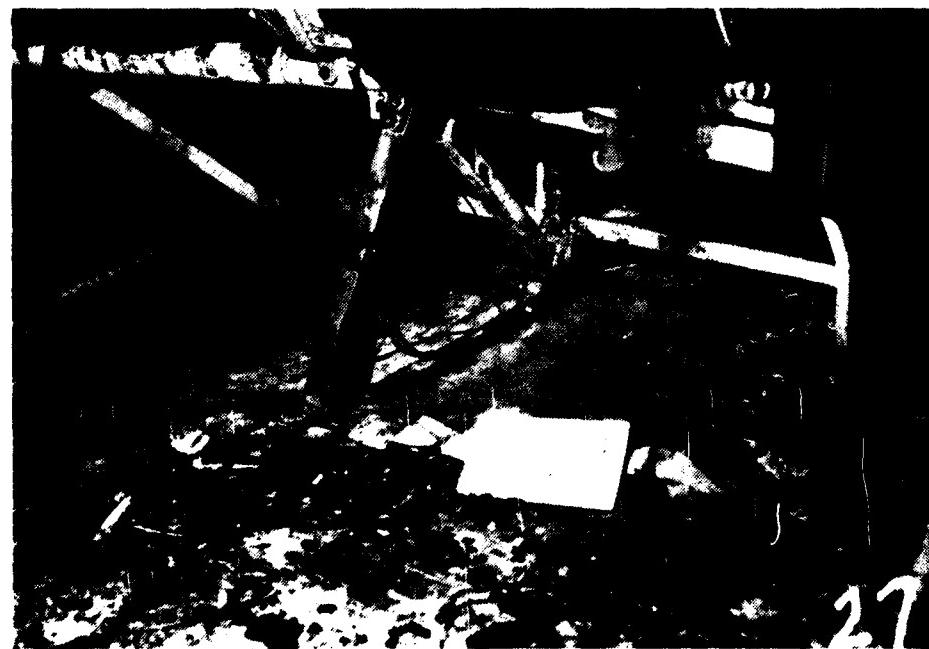
Lateral loading caused the inboard rear leg to buckle (figure 77) and the outboard rear leg to bend slightly. It is not possible to show conclusively whether the seat was supported by three or four legs when the leg buckling occurred. The vertical and lateral seat accelerations (figure 78) indicate the vertical impact which dislodged the front outboard track fitting could have occurred before the lateral pulse which bent the legs. On the other hand, seat J/L, a seat two rows to the rear with a similar leg construction, failed due to the lateral accelerations. All the other adjacent seats were modifications built to withstand at least 6 G, twice the strength of seats B/L and J/L. The modified seats did not experience any deformation.

Figure 77. Buckled inboard rear leg of seat B/L.

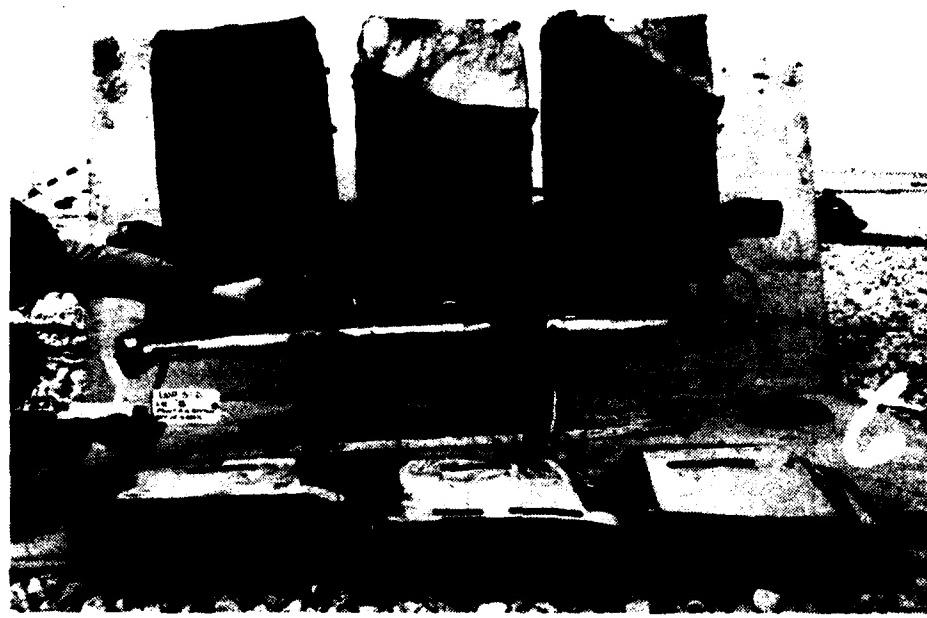
The front seat pan tube was deformed downward at both window and aisle seat positions (figure 79) and the rear seat pan tube was similarly deformed at the aisle seat position (figure 80). Since the fire had discolored the tubes at these locations, the deformations can be attributed to the heat softening the metal.

Figure 79. Deformed front seat pan tube of seat B/L.

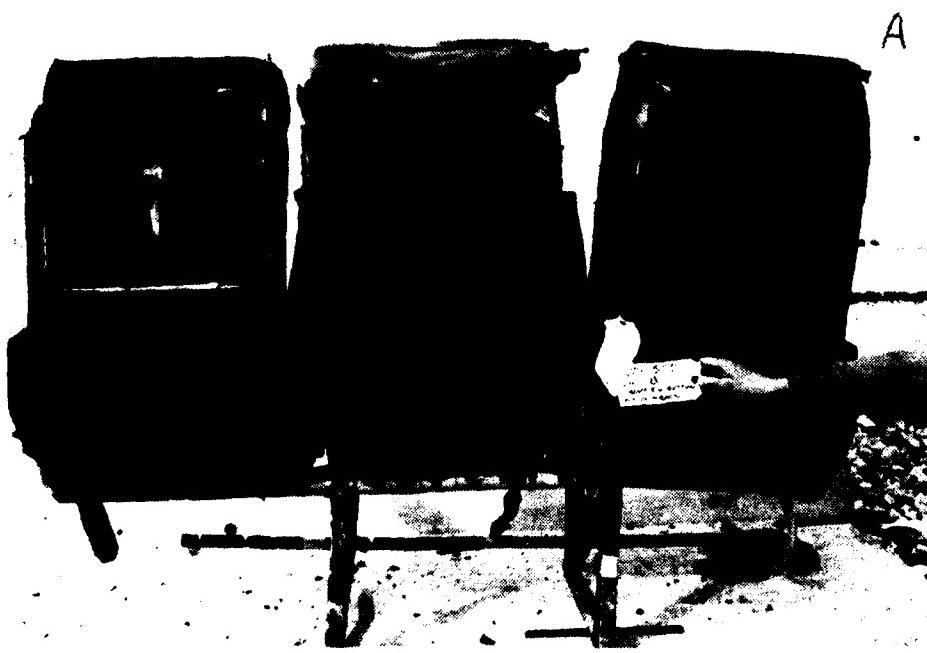
Figure 80. Deformed rear seat pan tube of seat B/L.

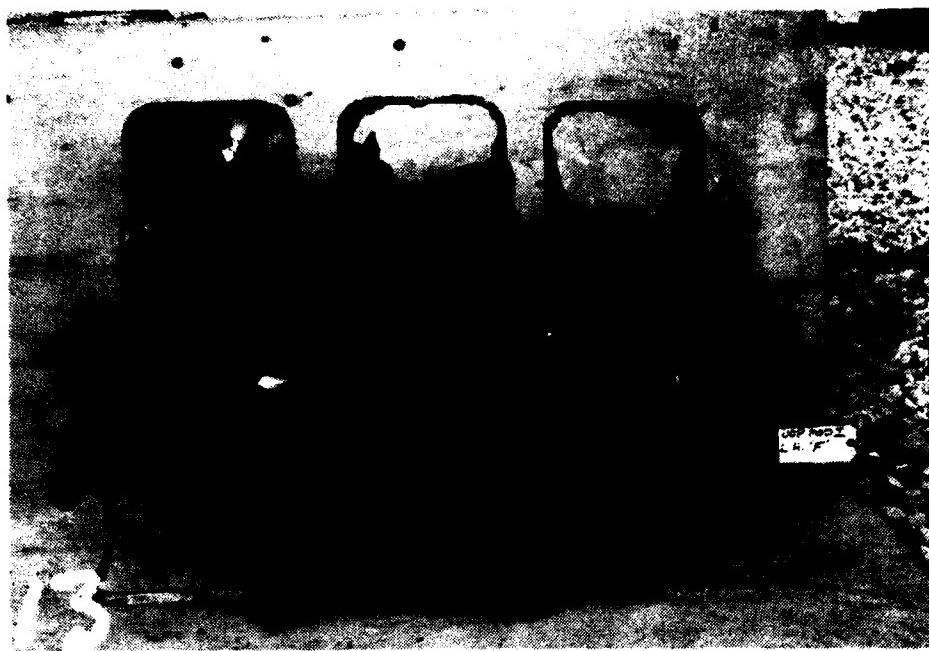
Figure 81. Damage to seat F/L.

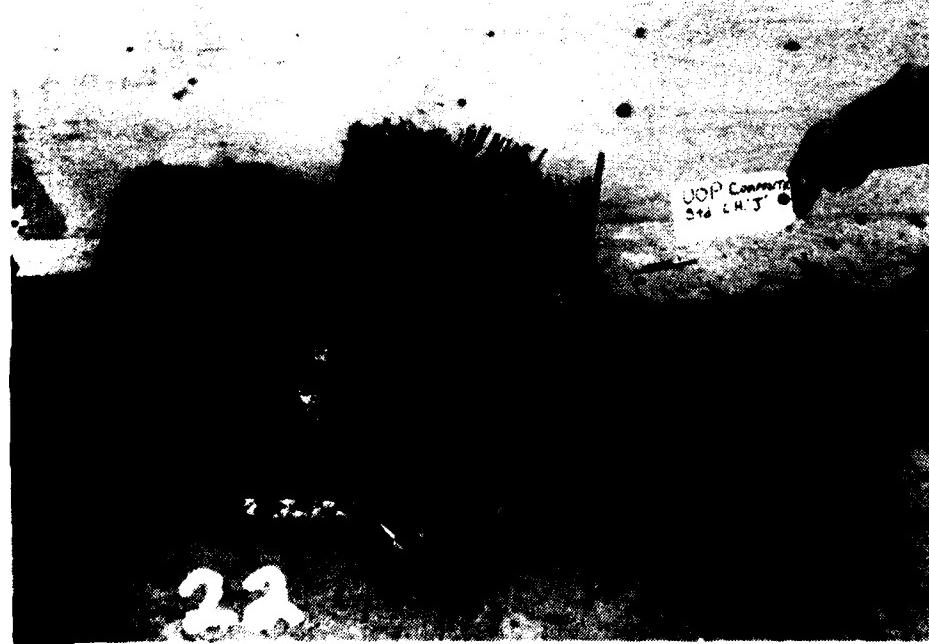
Figure 82. Deformed legs of seat J/L.

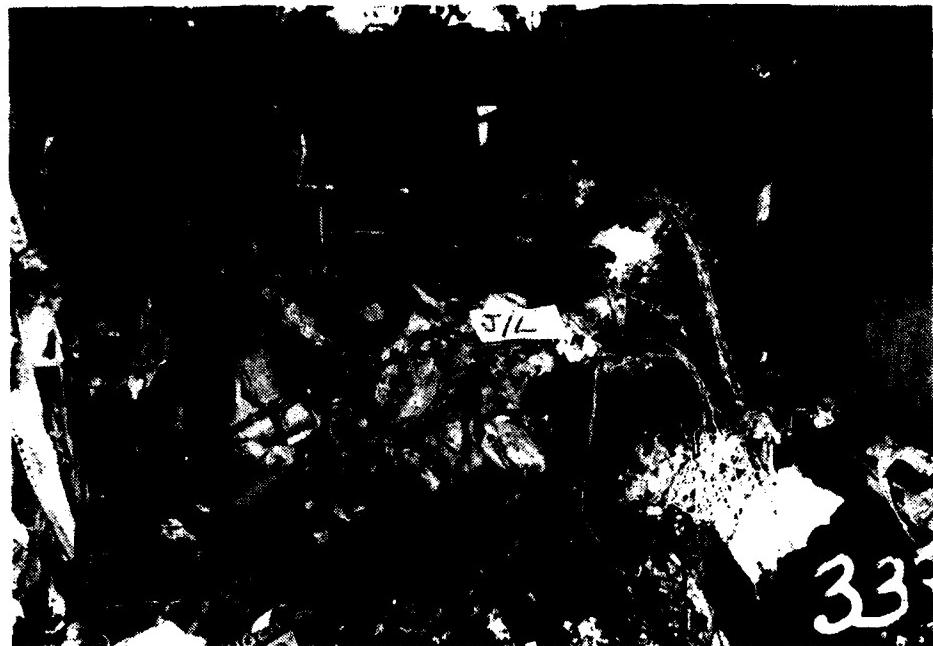
Figure 83. Posttest position of seat J/L.

A second film shows the inboard dummy falling sideways across the aisle and striking a battery pallet. When closely examined, the film briefly shows the heads of the other two dummies falling backwards. The seat's failure is also substantiated by the direction in which the seat's legs were deformed (figure 82). As shown, the seat pan was forced toward the aisle. If the sagging floor and heat had caused the seat to fail and placed it in the position in which it was found (figure 83), the legs would have bent in the opposite direction.
